DSC Notes on ANCOLD Paper

Oaky River Dam Failure

George Samios¹, Steve Gough²

Keywords: dam, flood, overtopping, collapse, remediation

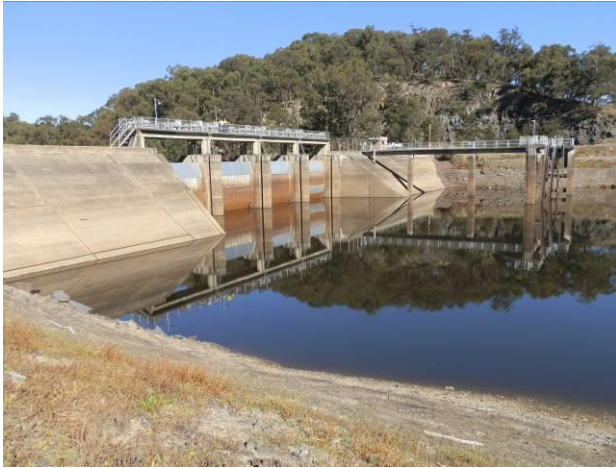
Photograph 2: Oaky River Dam – upstream side, pre-failure (2012)

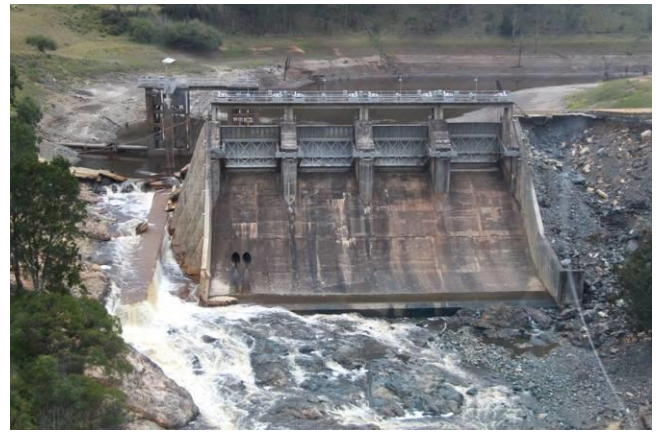
Photograph 3: Oaky River Dam Post-failure February 2013

1. The whole of the concrete face and rockfill right embankment section of the dam had collapsed, except for some remnants that remained on the upper reaches of the right bank abutment.
2. The gated central structure of the dam appeared in tact and structurally sound, including the right

3. One span of the access bridge connecting the right hand side embankment to the intake tower had collapsed. The intake tower appeared in tact with flood debris caught in the supporting piers and some debris observed on the upper deck level.

4. The rockfill from the left embankment section had partly washed away appearing to leave a short length of concrete face unsupported.
5. A large amount of concrete debris (including the fallen beam from the tower access bridge collapsed span) remained just below the right hand side embankment failure.

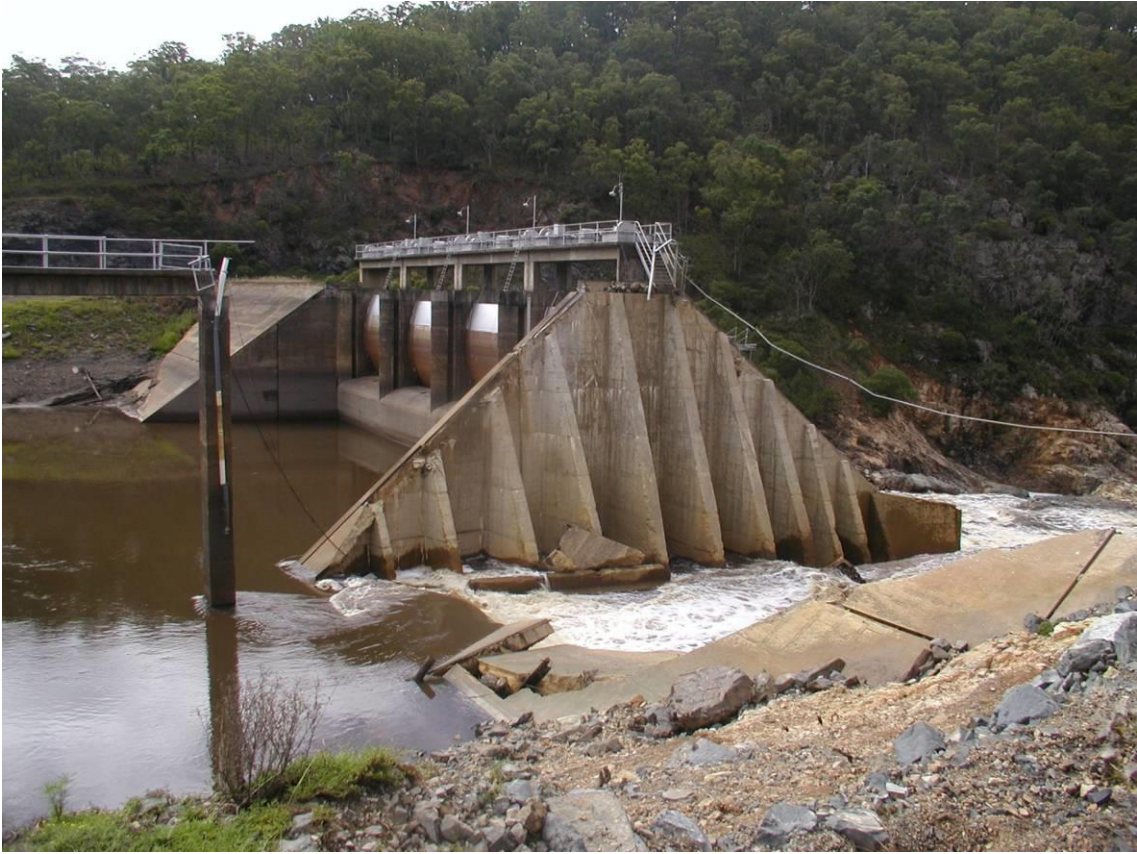
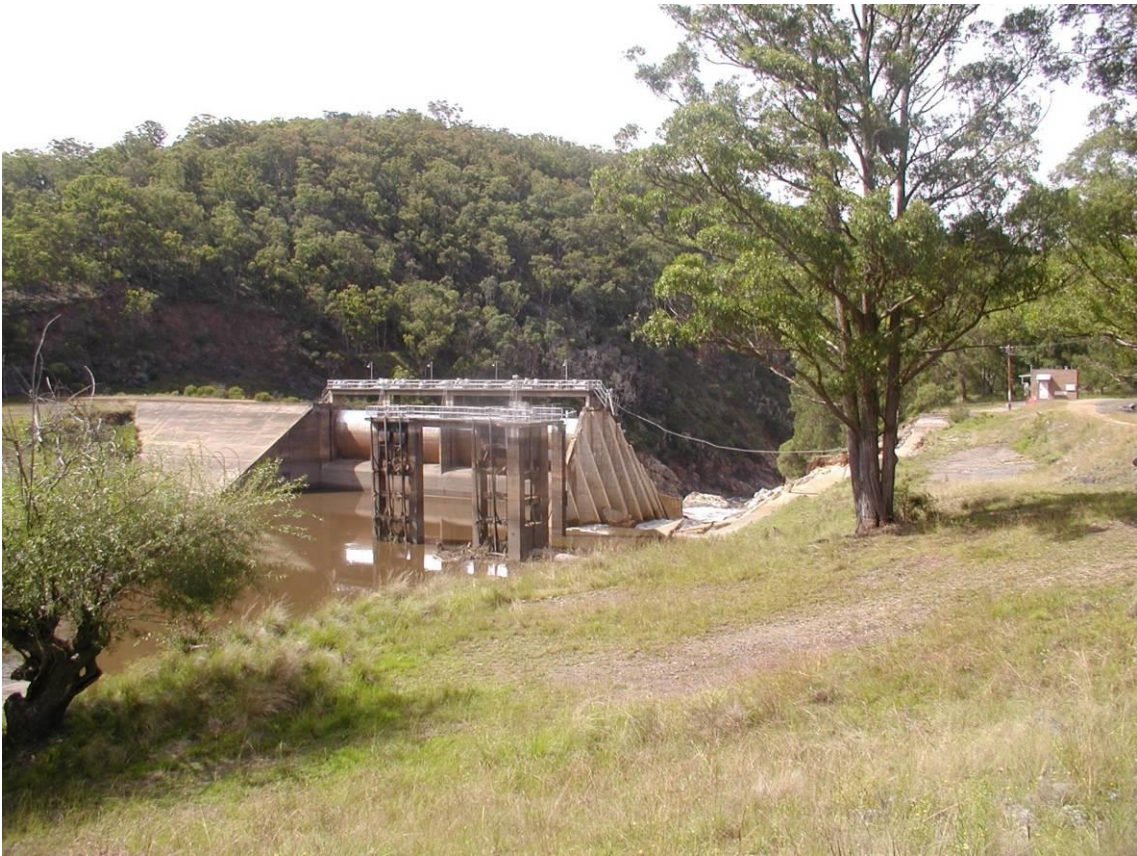
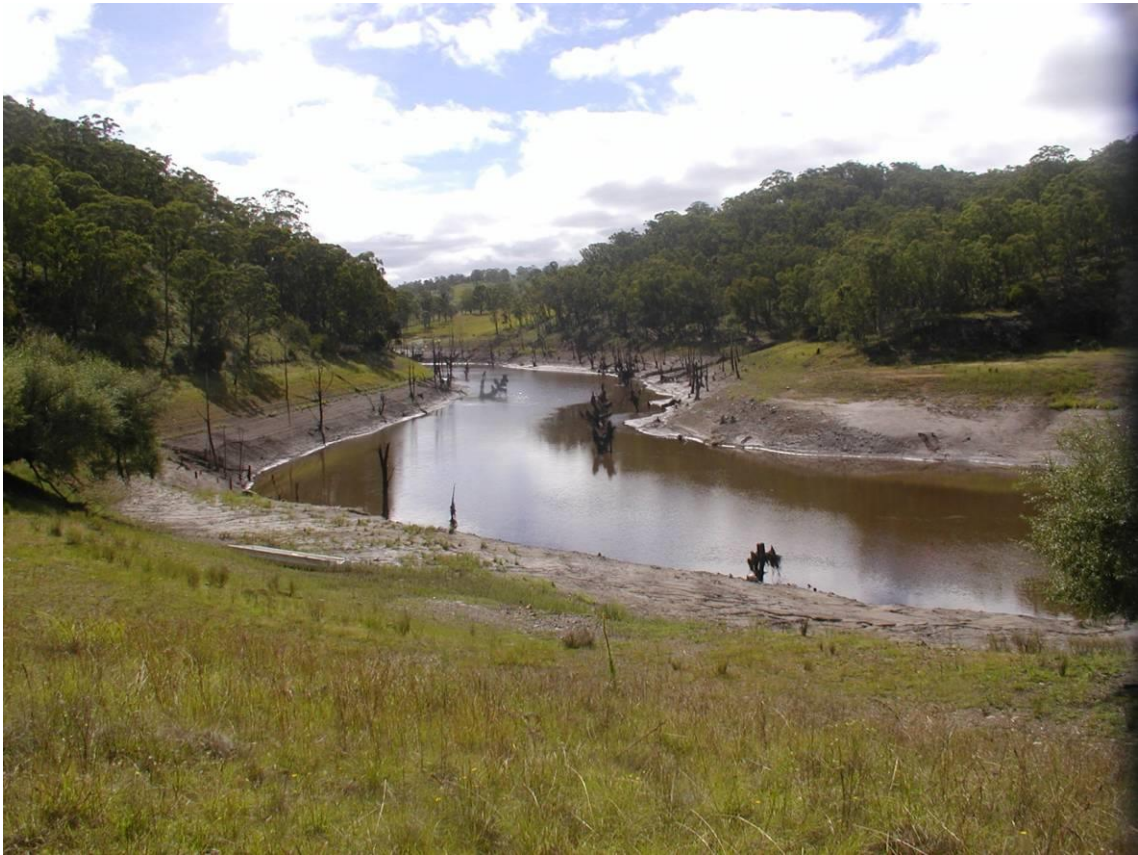
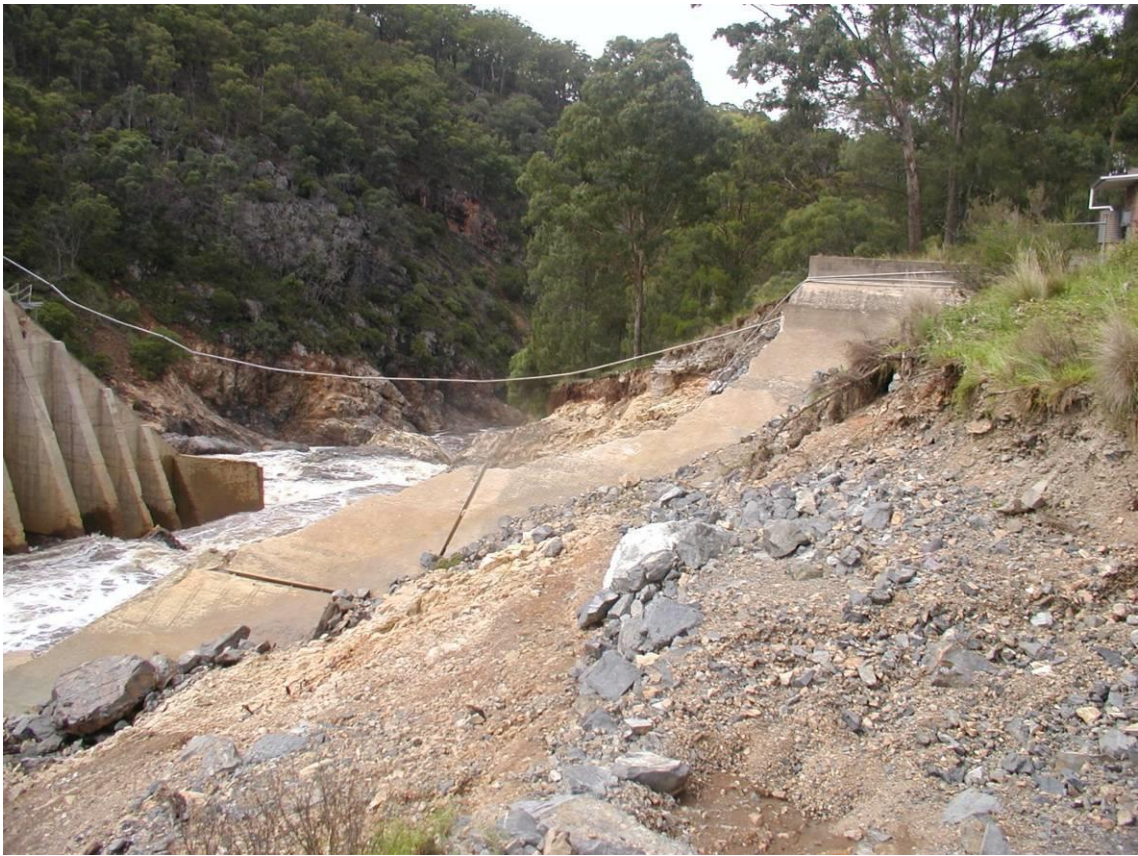
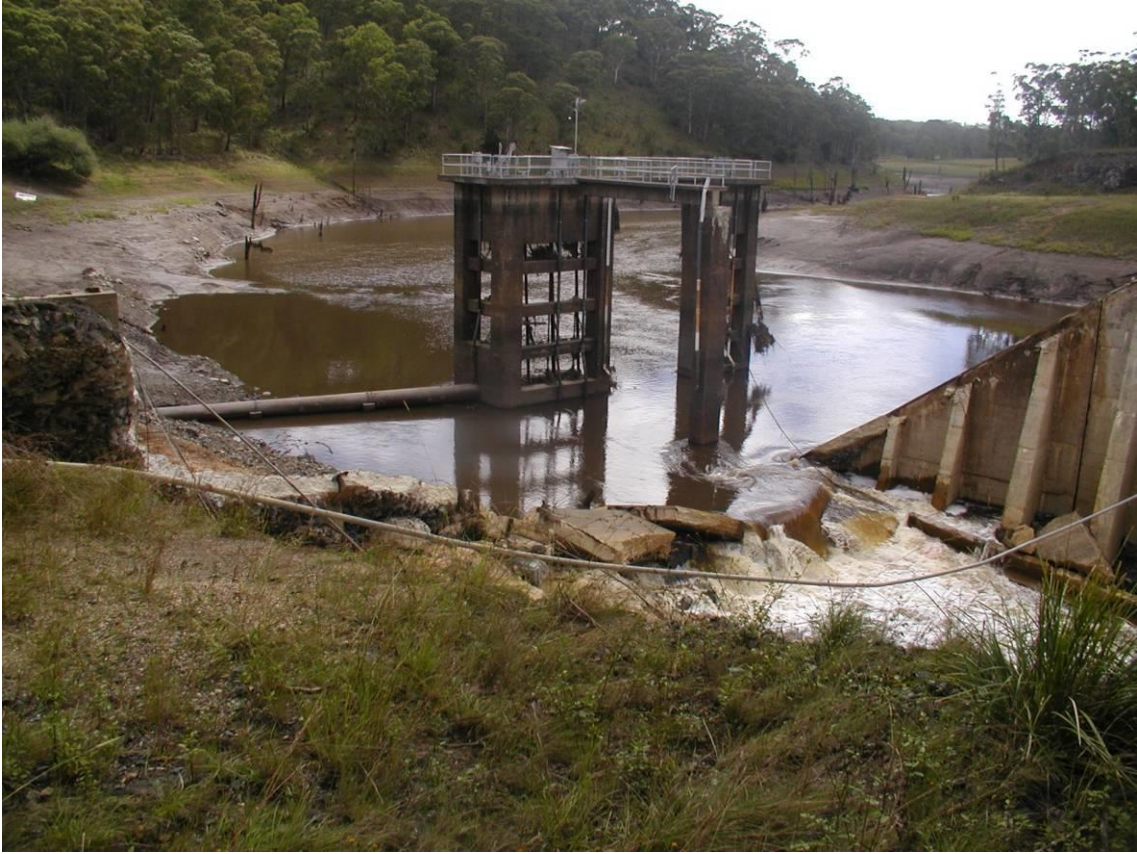
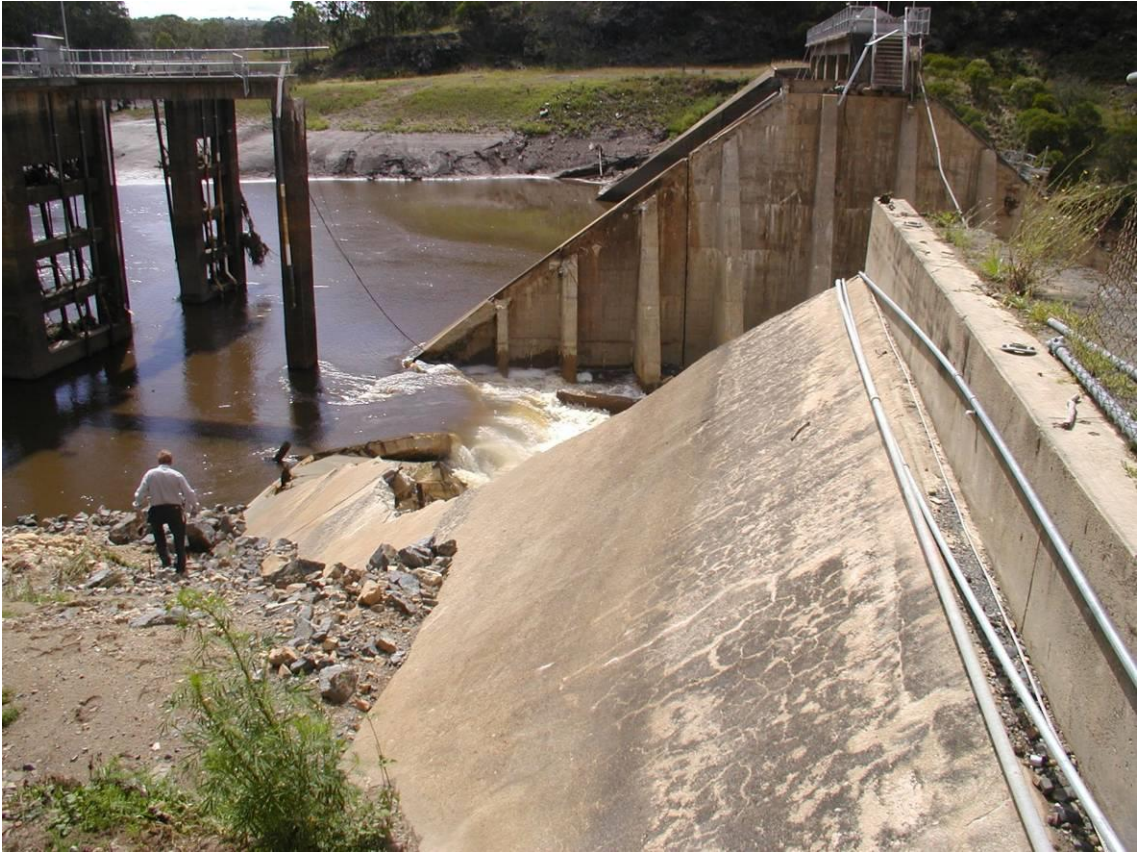
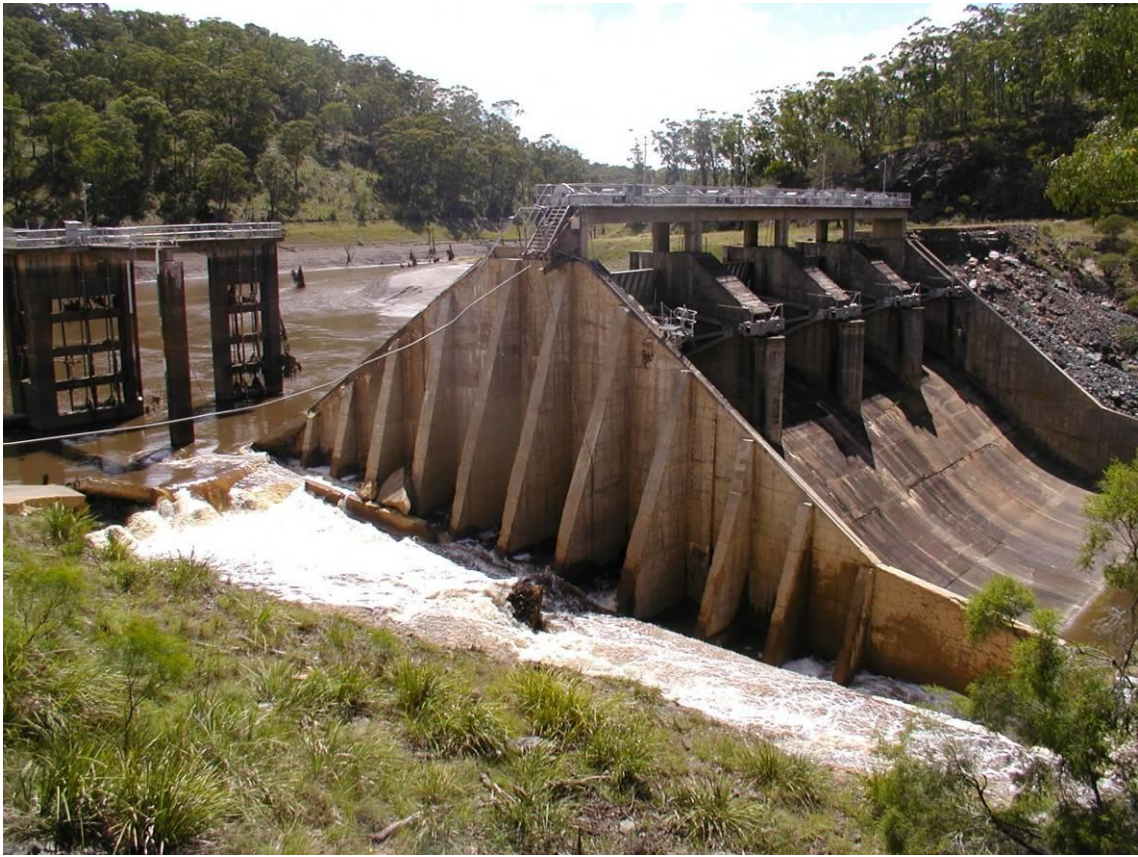
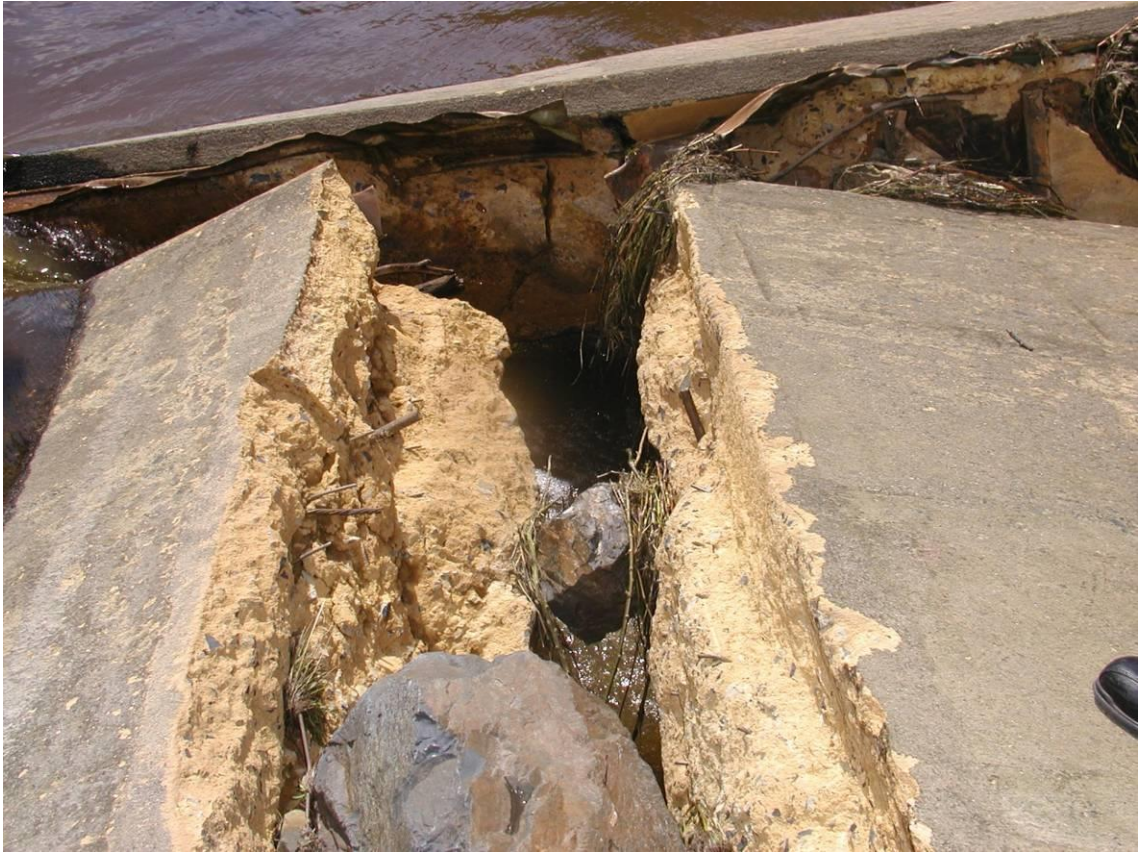
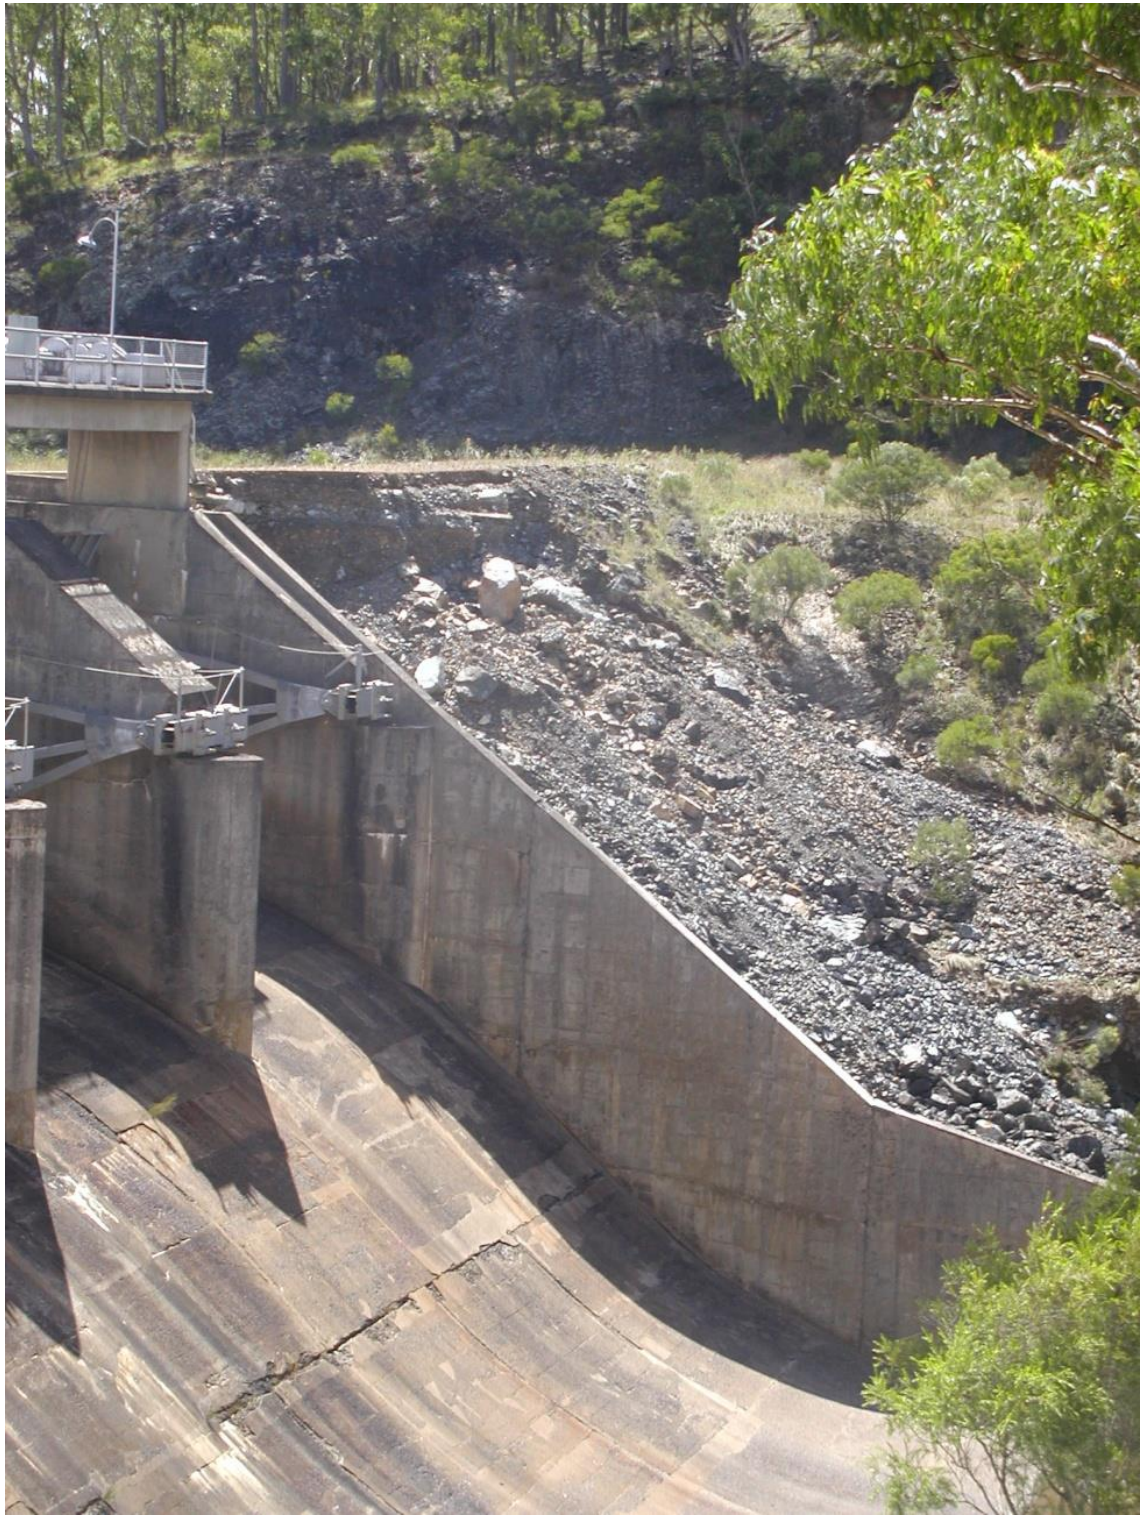
Appendix B Selected Photos from Inspection of Dam Failure

side counter-forted concrete wall that had been exposed following the embankment collapse.

6. The rock foundation of the dam's right abutment and the concrete outlet pipe concrete encasement was exposed.
7. A very small amount of reinforcement was exposed in the broken face slab pieces, but it was noted that the slab appeared to have very little reinforcement in general.

8. Copper waterstop was attached in parts to the right concrete wall of the gated structure and the remaining face slabs on the upper right bank. The copper waterstop was severely damaged.

9. Observation of surface vegetation damage and direction indicated water passage over and around the right abutment of the dam.
10. Cabling from the right bank to the dam's gates was damaged and left hanging across the space of the failed right hand embankment. Power connection had still not been restored due to obvious safety concerns. Cabling was later identified as control cabling. Power cabling had been washed away.

11. The gates were inoperable (due to the lack of power available). The gates were all closed – except that Gate No. 1 was slightly higher than the rest, assumed to be still open by the reported 14 inches (360mm).
